Troubleshooting Exterior Insulation and Finish Systems (EIFS) Cladding

Introduction / Objectives

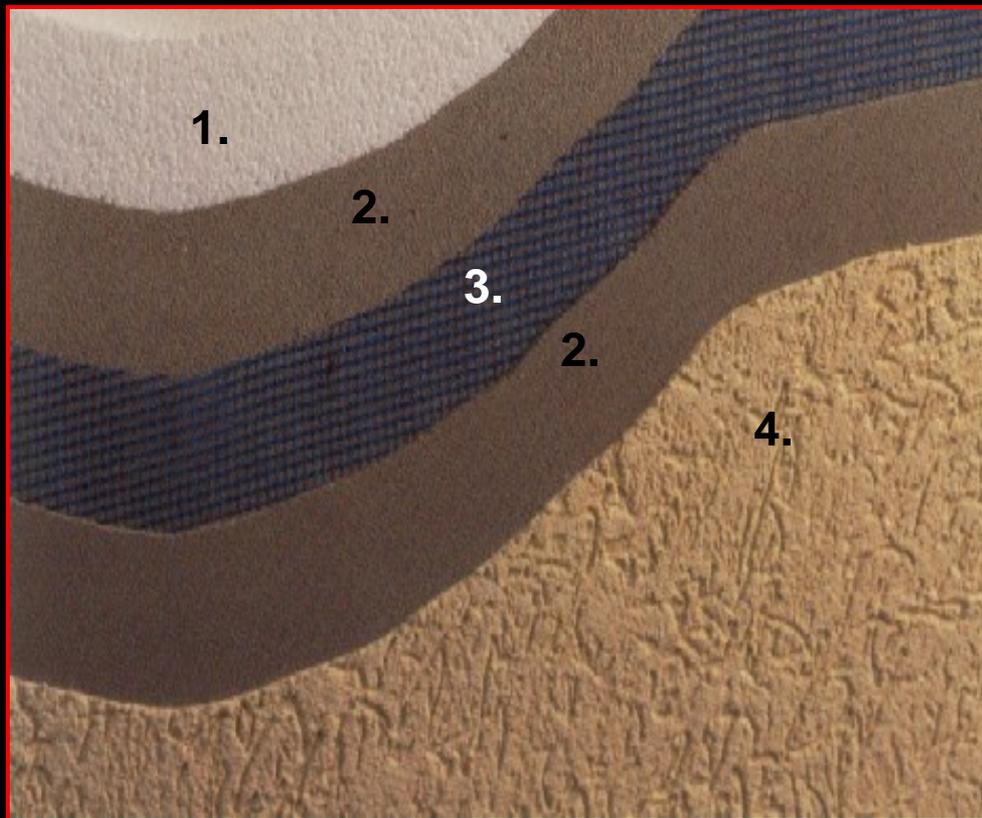
Barrier Type EIFS

1. Expanded Polystyrene Insulation Board (EPS)
2. Base Coat
3. Reinforcing Mesh embedded in base coat (for impact and moisture resistance)
4. Integrally colored acrylic finish

Typically “adhered” or “mechanically attached” directly to an underlying / approved substrate

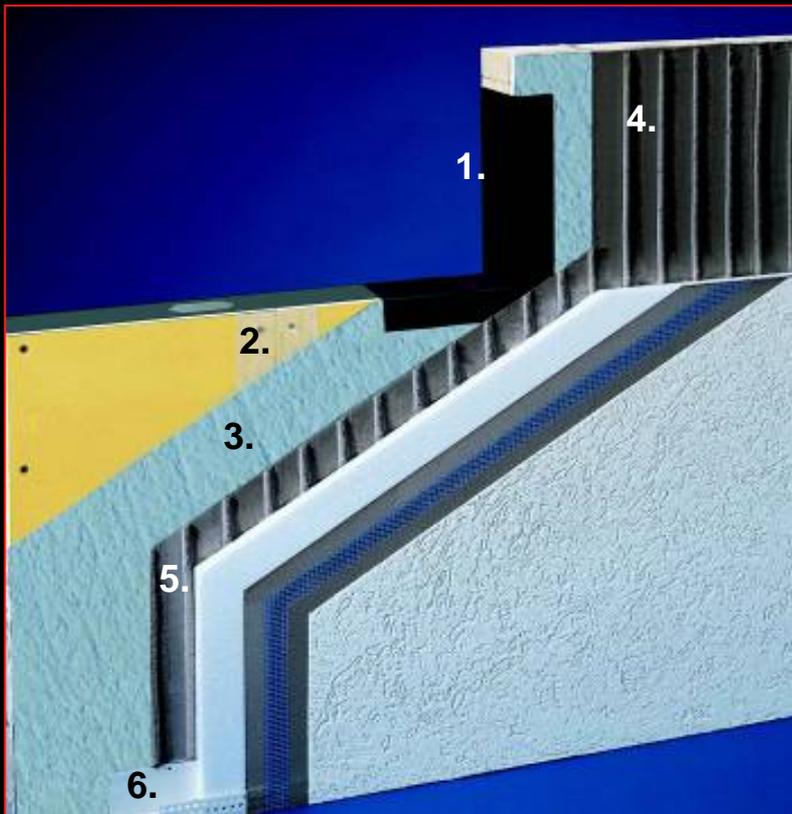
Drainage Type EIFS

1. Flashing at Rough Opening
2. Grid Tape Reinforcing
3. Secondary Weather-Resistive Barrier (WRB)
4. Vertical Notch Trowel Adhesive
5. Drainage Plane
6. Horizontal Weep Detailing*

* plastic track is not appropriate in fire-rated construction

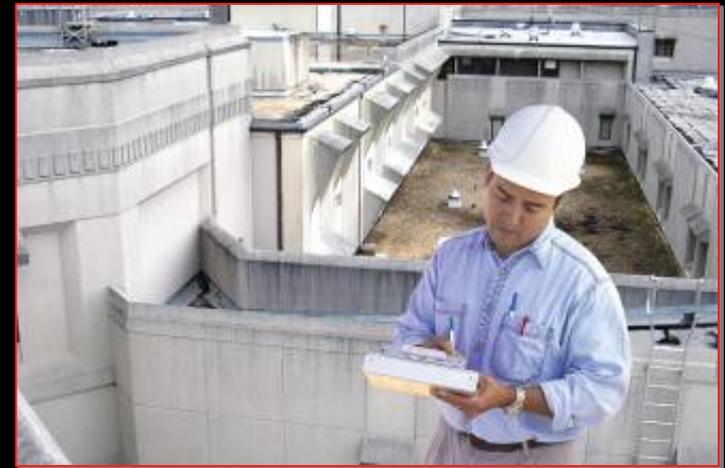
I – Inspection - Annual

- Conduct visual inspection of EIFS clad building envelope to identify any possible issues
 - Surface damage / Sealant joint failure
- Performed by facility manager or other qualified personnel
- Address any identified issues
 - Consult EIFS cladding manufacturer

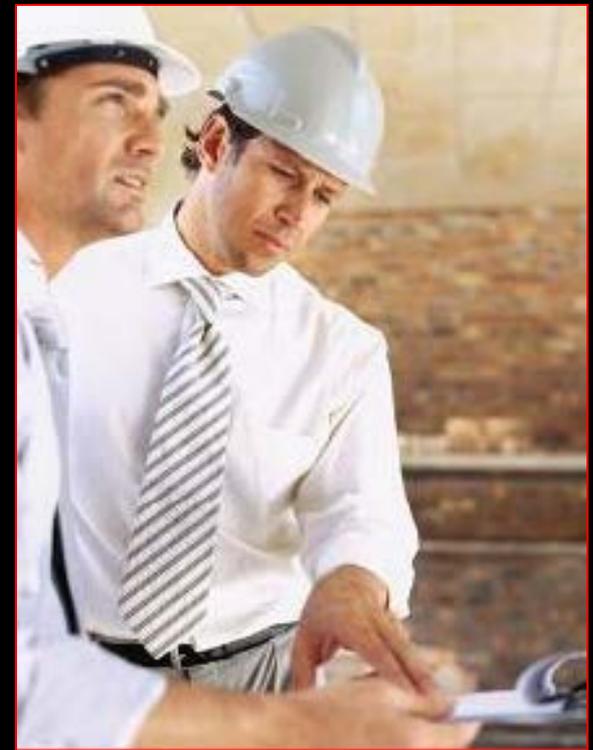
I – Inspection - Comprehensive

- Conduct visual and physical inspection of EIFS clad building
 - Underlying wall issues / moisture intrusion, etc.
- Performed by an Envelope Forensics Specialist
 - Trained and experienced in EIFS cladding
- Develop comprehensive “assessment and scope of work”

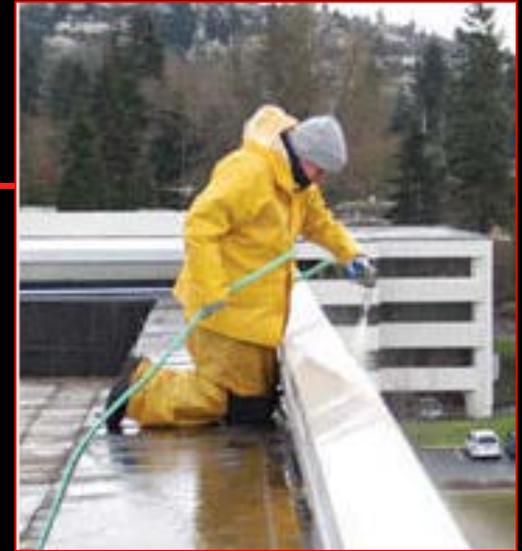
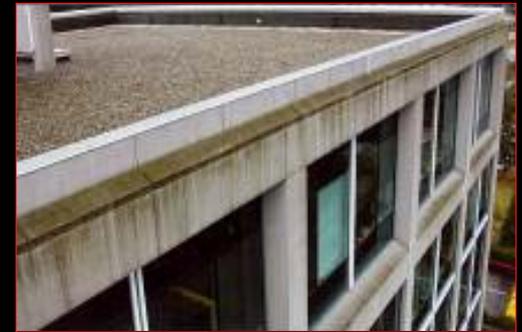
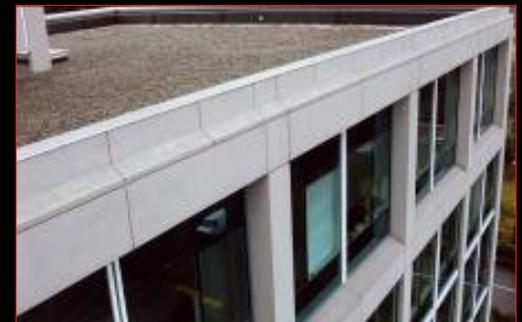
II – Cleaning

- Initial step of scope of work
 - May expose underlying / hidden conditions
- Clean with benign detergents, low-pressure / high-volume water and non-abrasive techniques
 - Utilize a trained professional to perform cleaning
- Conduct additional inspections if any additional signs of damage are found

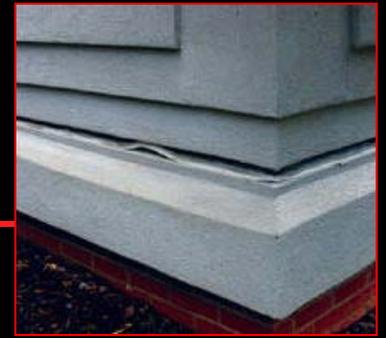
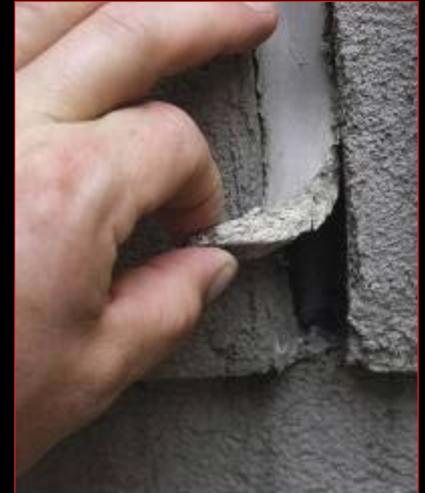
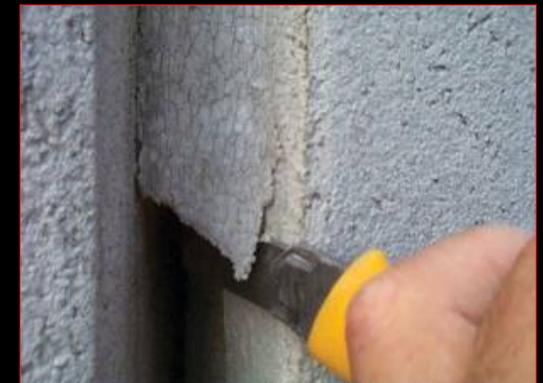
III – Sealant / Replacement

- Defective / aged sealant to be properly identified / removed
 - New sealant with primer to be replaced
- Verify joint pocket / bonding surfaces are sound and acceptable for the new sealant – repair as necessary
- Likely require trained “waterproofing” / restoration contractor

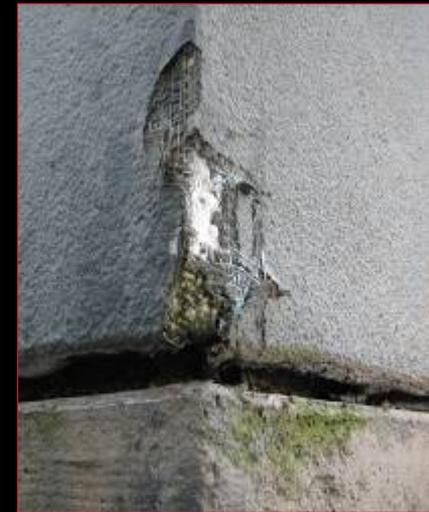
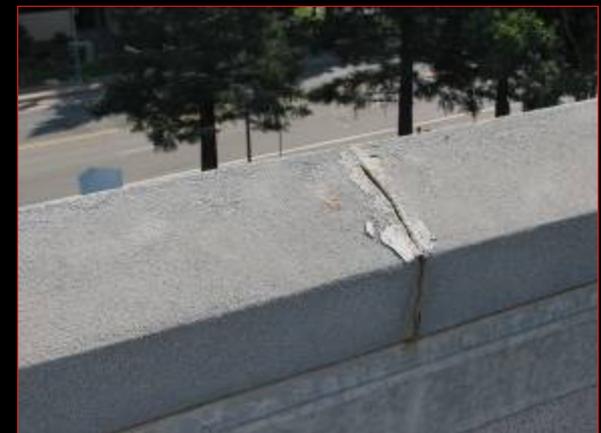
IV –Surface Damage Repair

- Where EIFS surface is damaged it must be repaired
 - Utilize proper EIFS repair procedures
- Repair may be simple - surface treatment – or more complex – removal and replacement
- Trained EIFS installation contractors “may” be needed for repairs

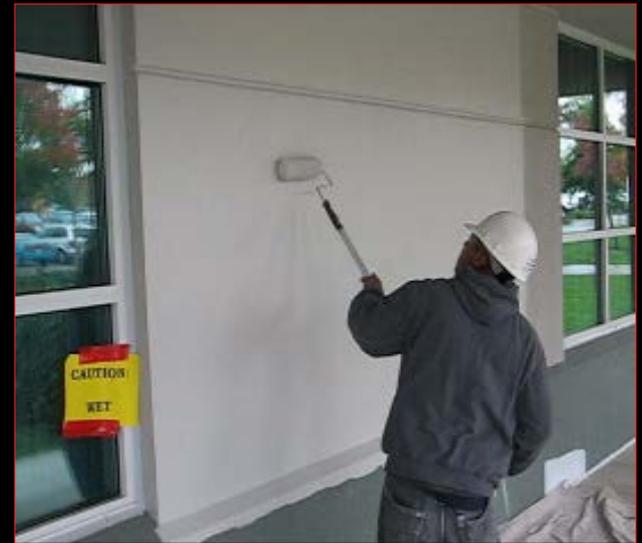
V – Architectural Recoating / Overcladding

- **Recoating**: Using surface compatible primers and coatings to coat the existing EIFS lamina and repaired sealant
 - Utilize a professional coatings contractor

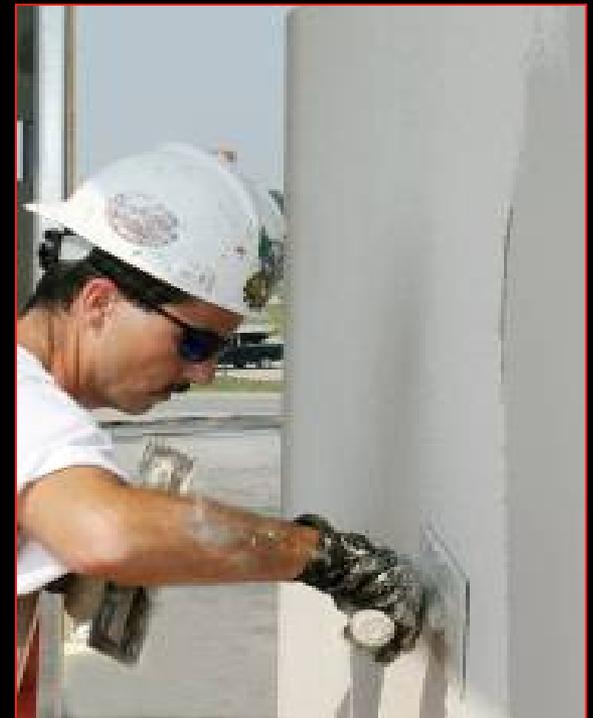
V – Architectural Recoating / Overcladding

- **Overcladding**: Using EPS shapes, reinforcing mesh, base coat and “new” finish colors / textures to create an entirely new look
 - Utilize a trained EIFS installation contractor
- Complete Make-Over if you will

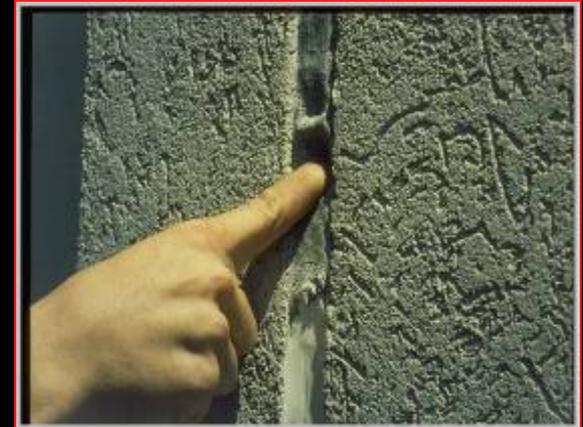
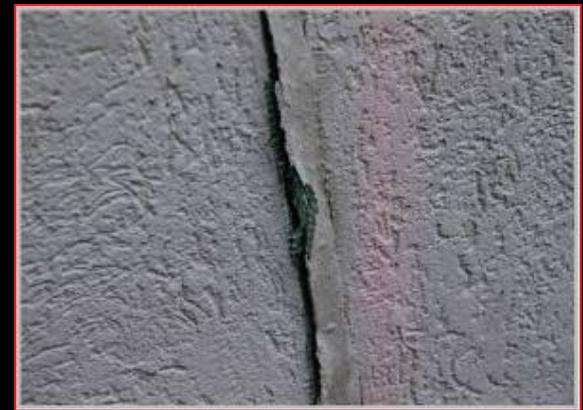
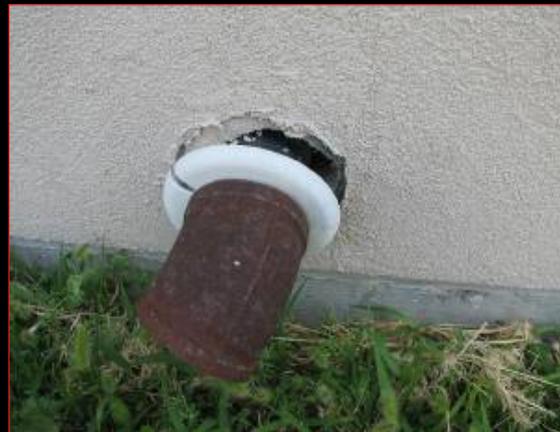
- **Sealant Issues**

- Sealant incorrectly installed
- Joint pocket not properly prepared
- Adhesive / cohesive and/or substrate failure
- Improper proportioning of joint
 - Joint too narrow to handle movement
- Wrong backer rod – “closed cell”
- No sealant at all

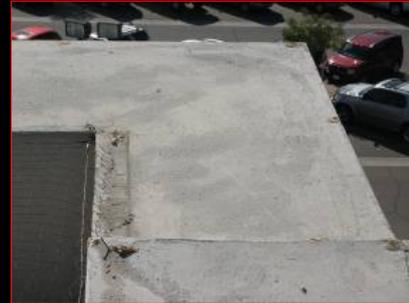
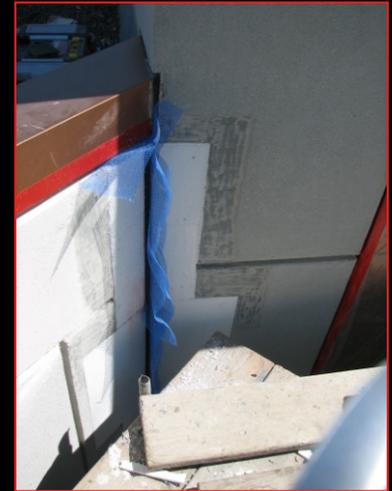
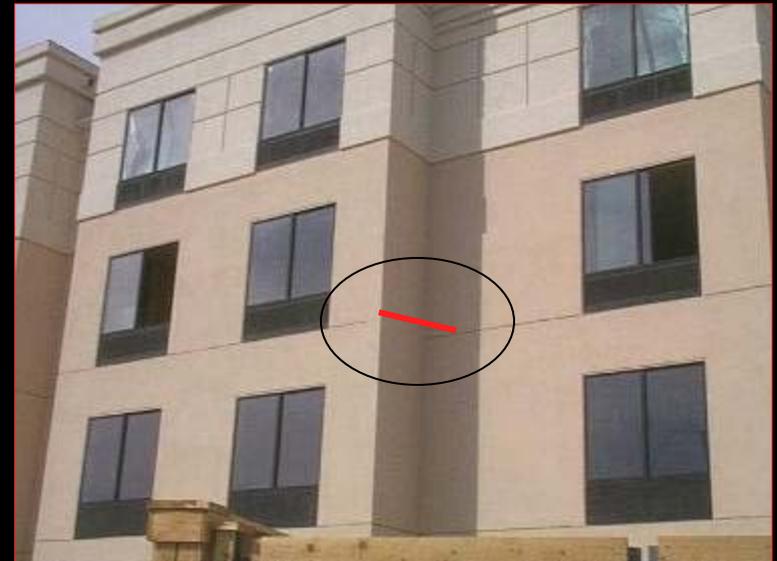
- **Original “EIFS” Architectural Details were not correct**
 - Improper slope of horizontal EIFS surfaces
 - Lack of expansion joints
 - Stress / compression / movement cracks
 - Improper insulation board thickness
 - Minimum $\frac{3}{4}$ ”
 - Behind aesthetic grooves
 - EIFS used as “parapet”

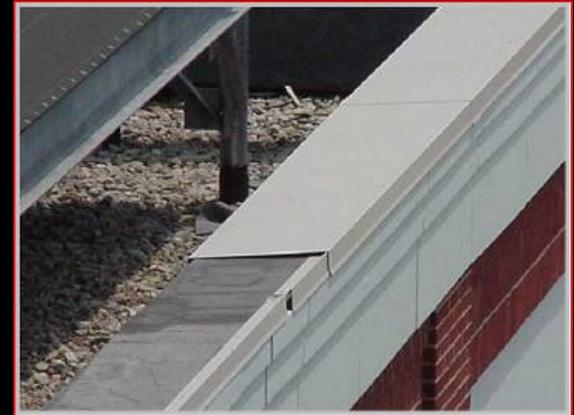
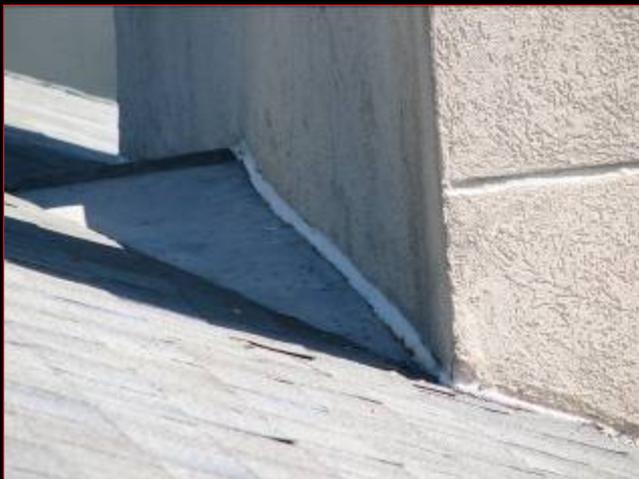
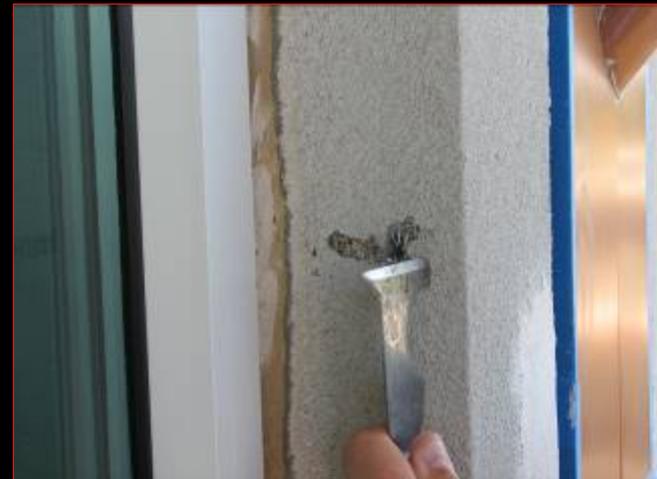
- **Penetrations & terminations not detailed or installed correctly**
 - Parapet copings improperly designed / sized
 - Flashings omitted
 - Windows installed in wrong plane
 - EIFS terminated tight to roof

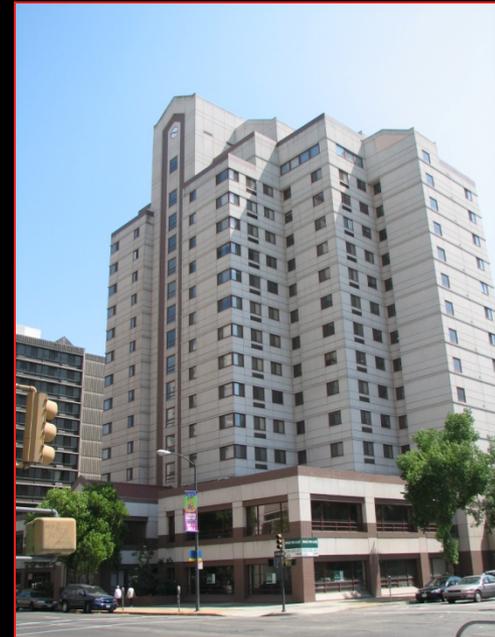
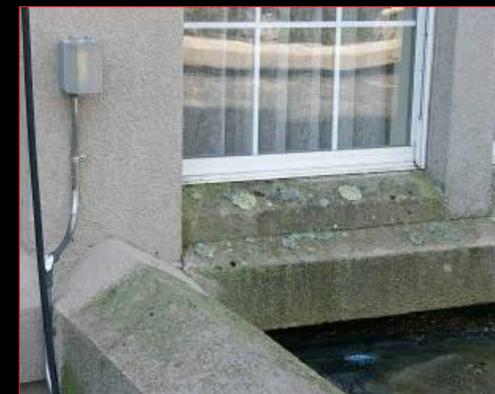
- Original building “design” did not anticipate / support ability to:
 - Physically “inspect” the exterior envelope
 - Proximity to adjacent buildings limiting access
 - No roof mounted swing staging
 - Easily implement repairs
 - Shed storm water & dirt build-up
 - Provide for general maintenance

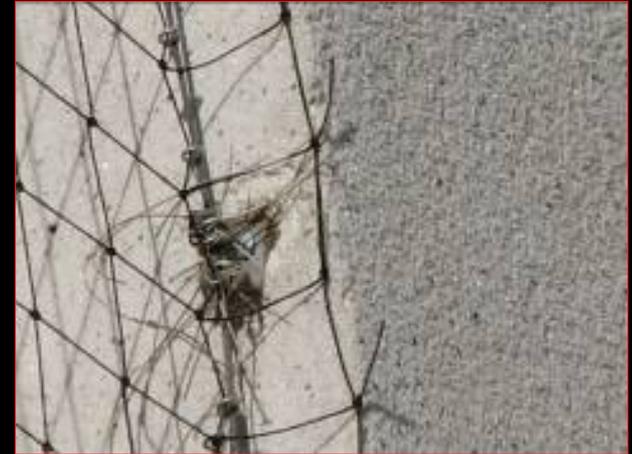
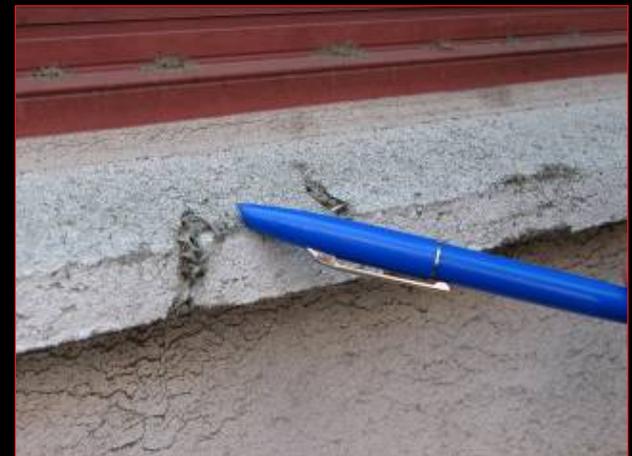
- **EIFS surface damage**
 - Impact / abuse
 - Storm
 - Improper fixture attachment
- **Moisture intrusion**
 - Leaking windows
 - Sealant / flashing failure
 - Roof coping
 - Other envelope component failure
 - Improper installation
 - Degradation of underlying building materials

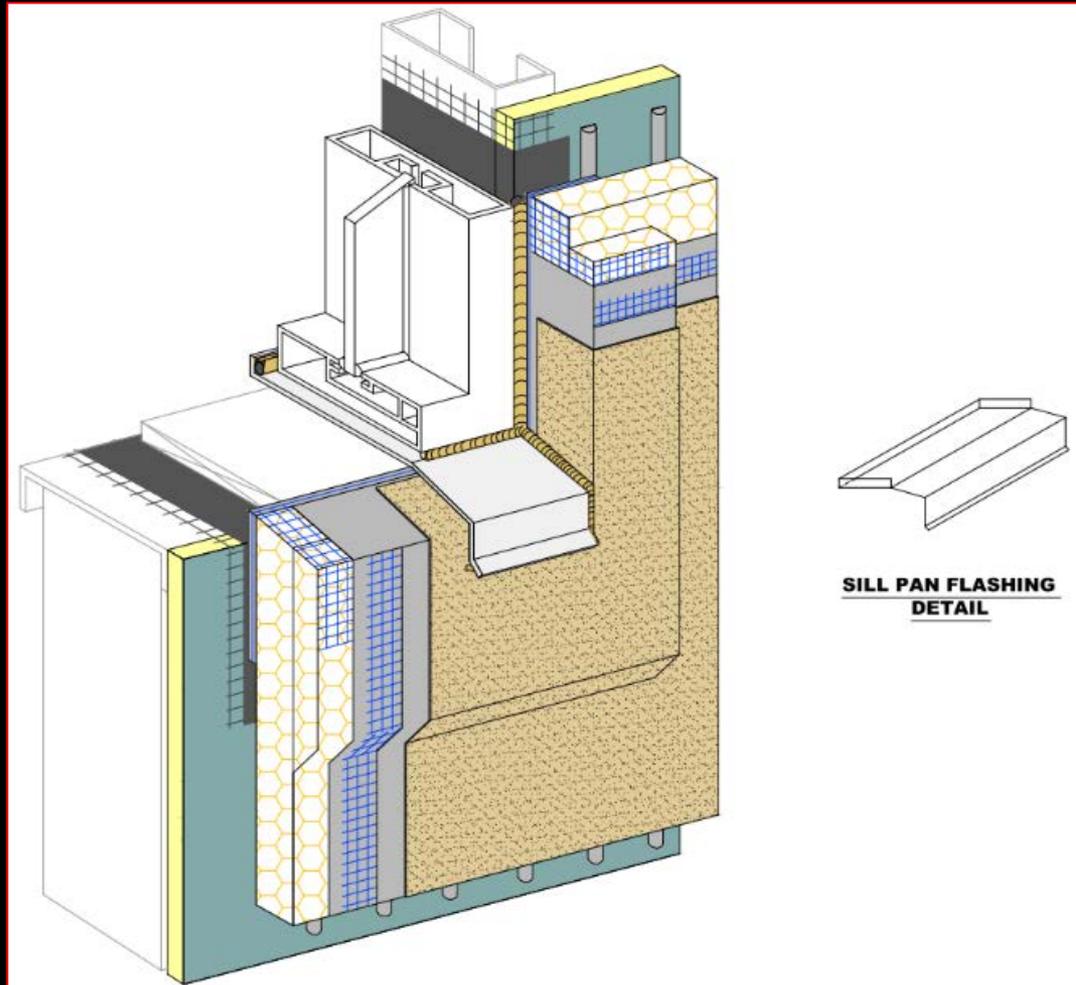
Window Penetration / Flashing

Windows must set in Sill Pan Flashing – required by code

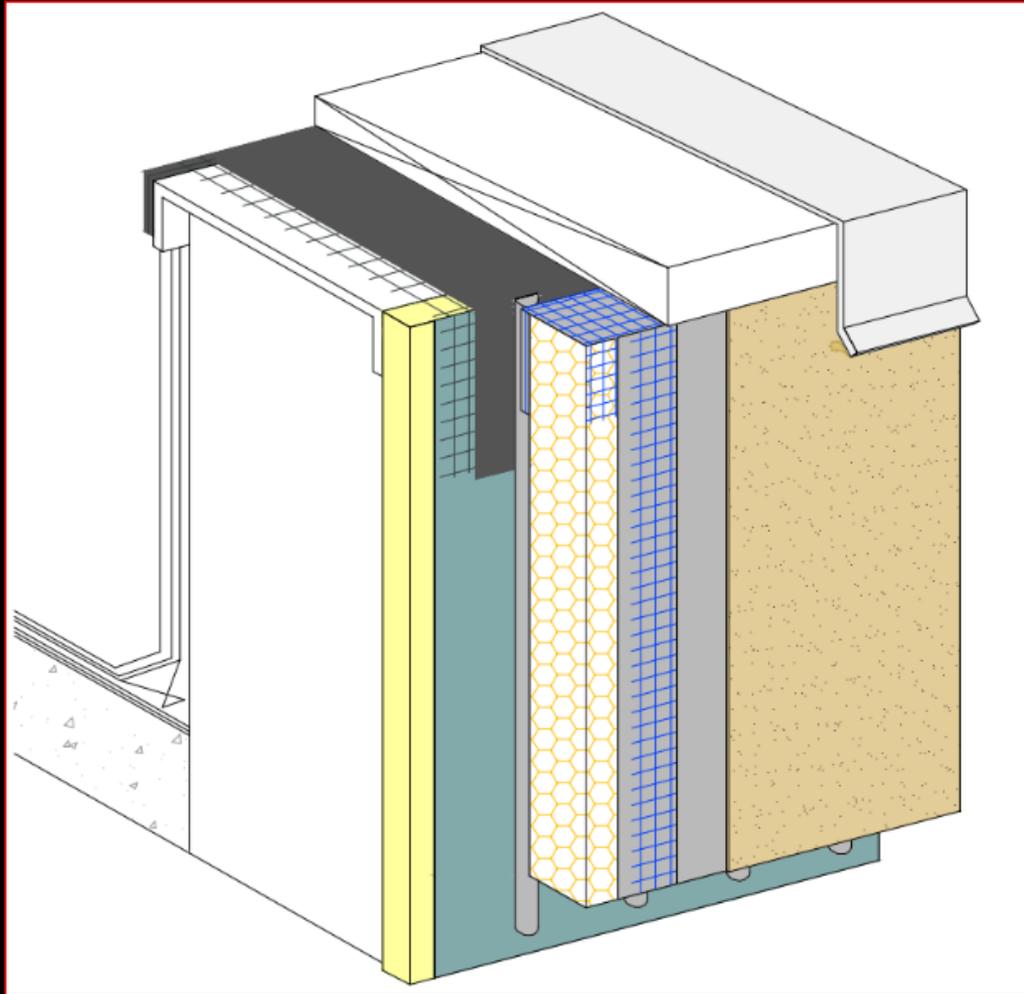
Metal Coping at a Parapet

Min. 2-1/2" coping coverage over EIFS / Flash top of wall

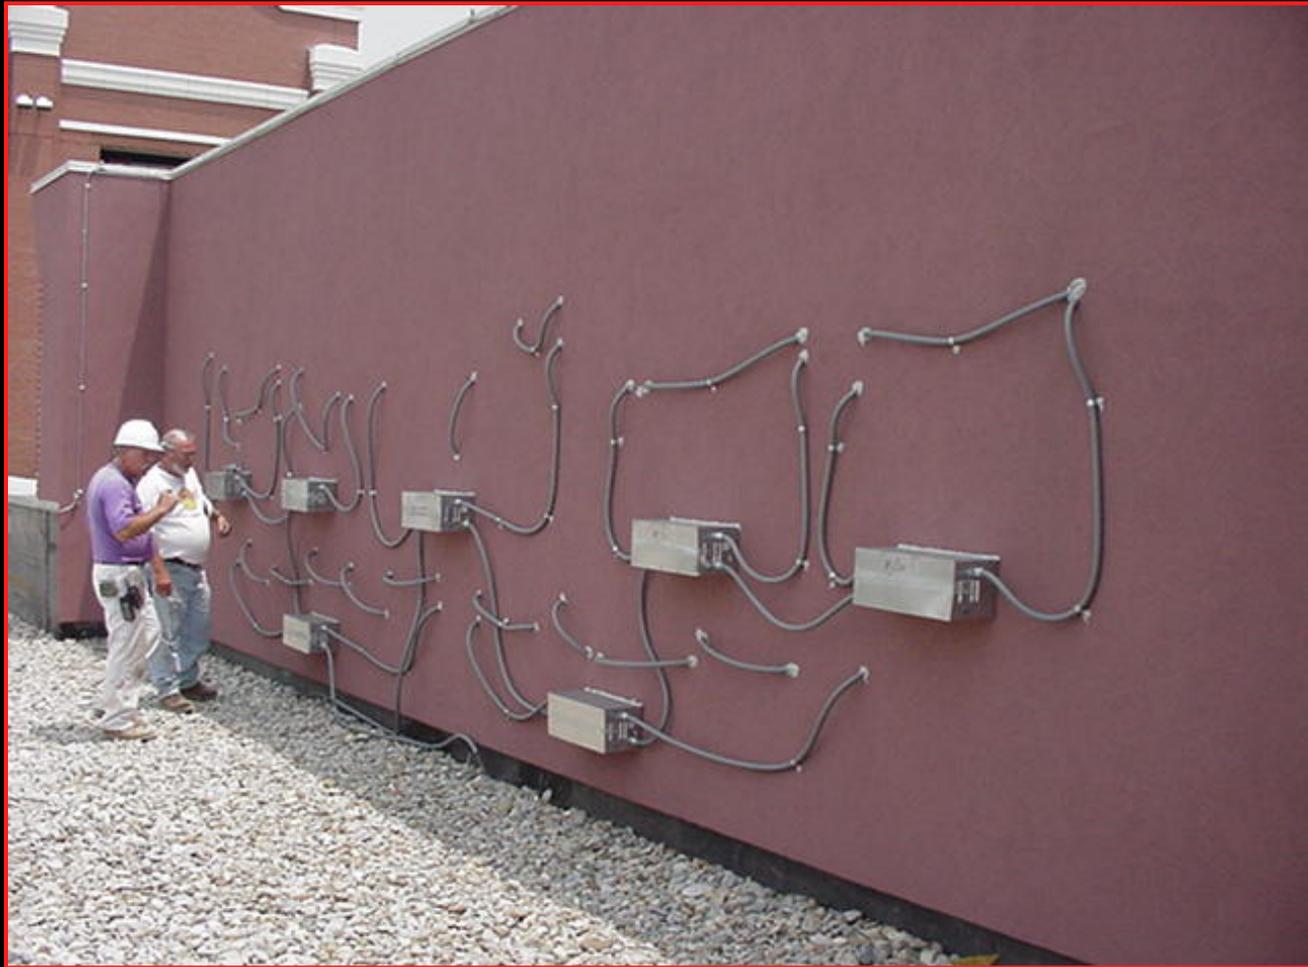
Pipe / Conduit Penetration

Signage attachment / penetration coordination is critical - or else 46

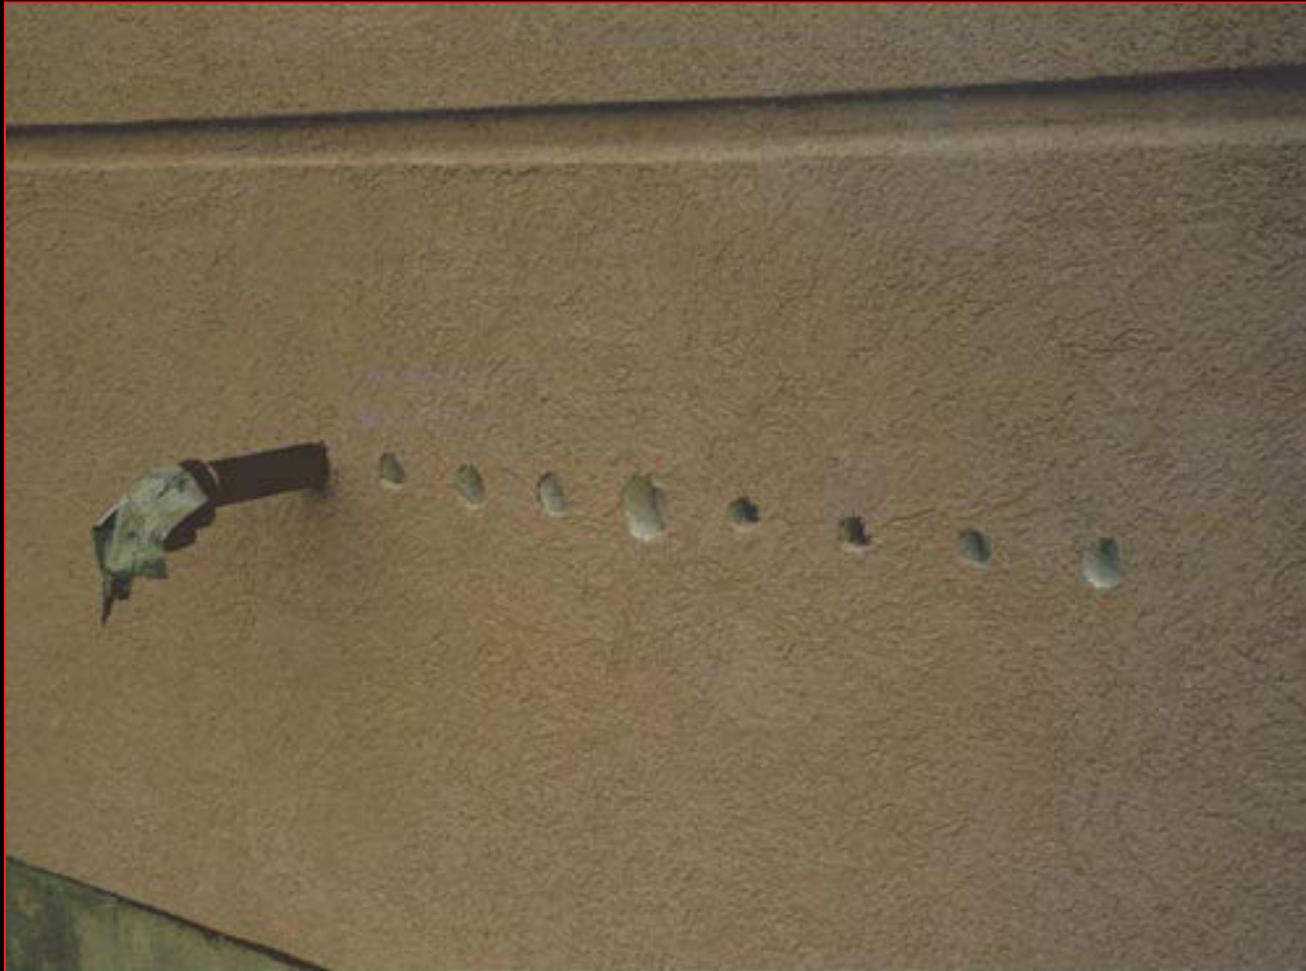
Pipe / Conduit Penetration

Result of 'zero' coordination for penetrations

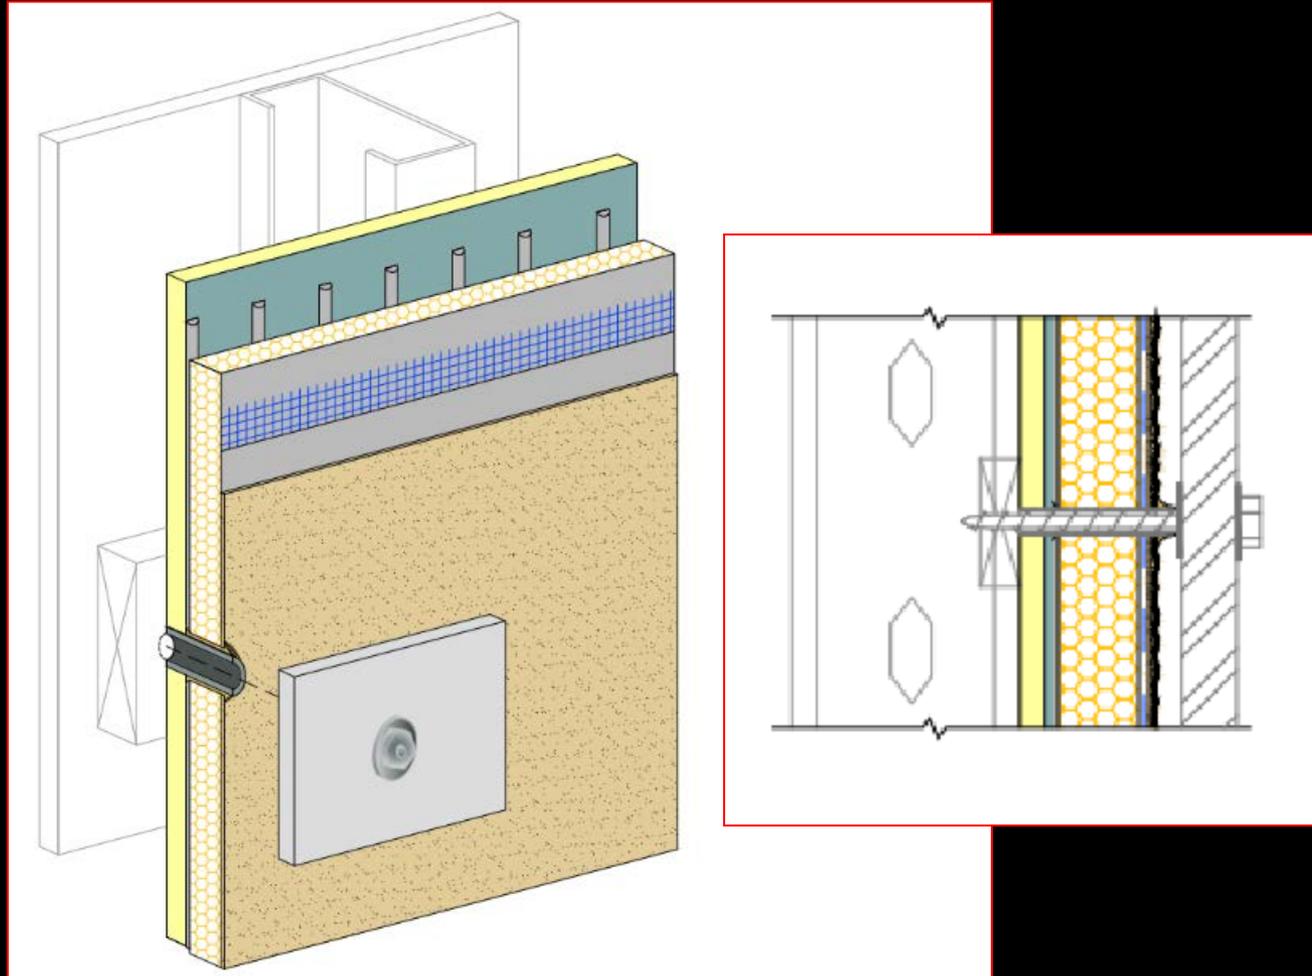
Signage / Fixture Attachment

Provide “compression sleeve” at fastener point

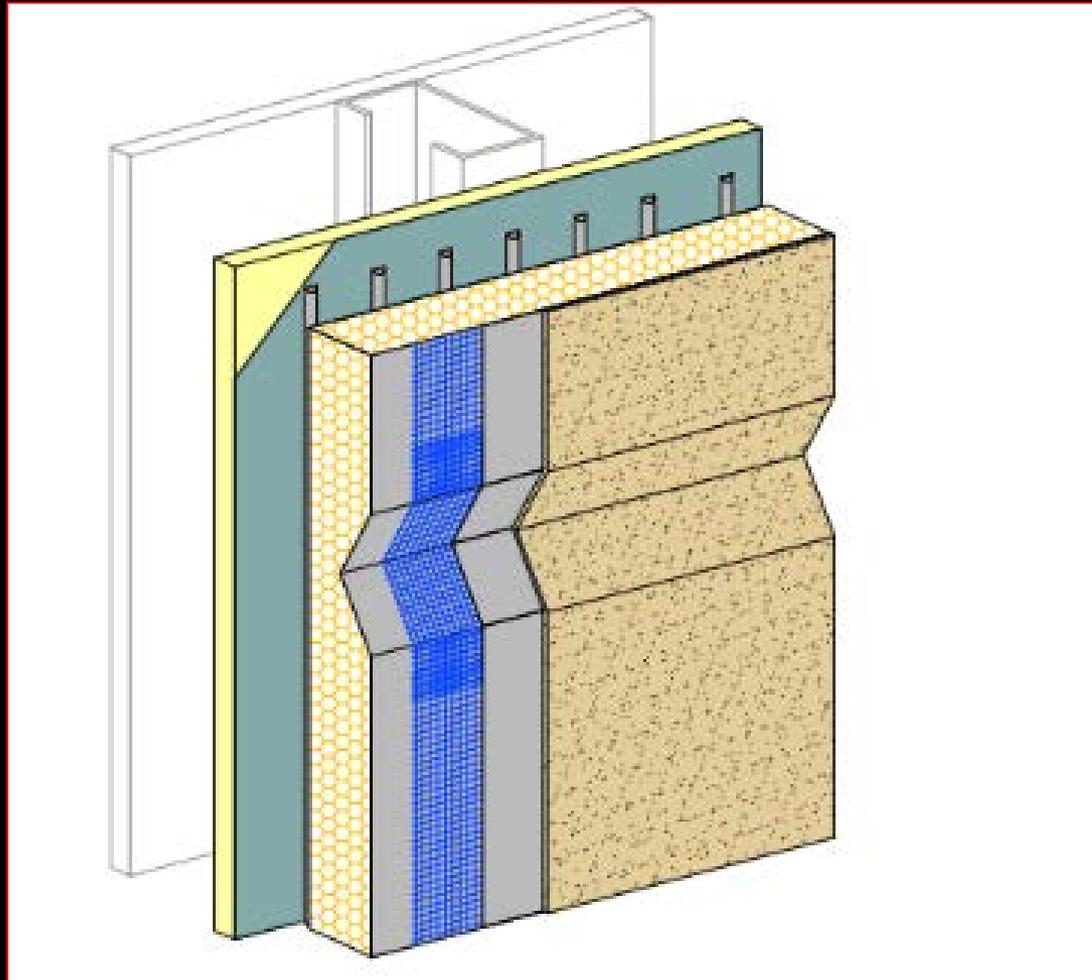
Aesthetic Groove

Min. $\frac{3}{4}$ " Insulation thickness behind groove

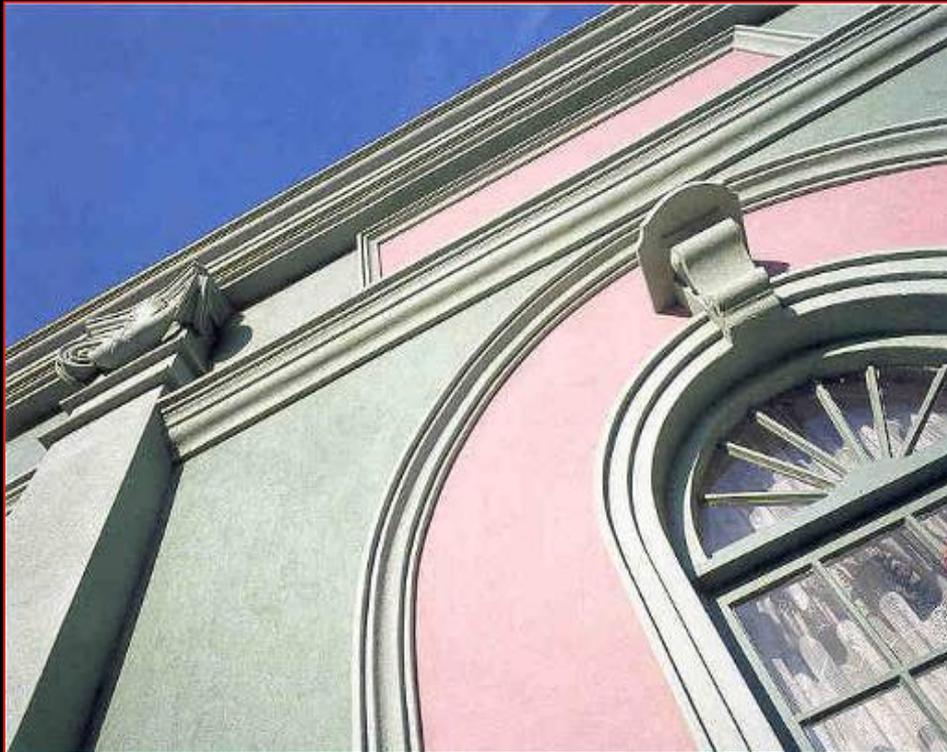
Slopes / Projections / Trims

- **DO NOT specify or accept “Urethane Coated” shapes** - not fire tested / non-compatible
- **Slope horizontal surfaces min. 1:2 ratio** - dirt build-up / streaking
- **Limit sloped surface projection to 12”**

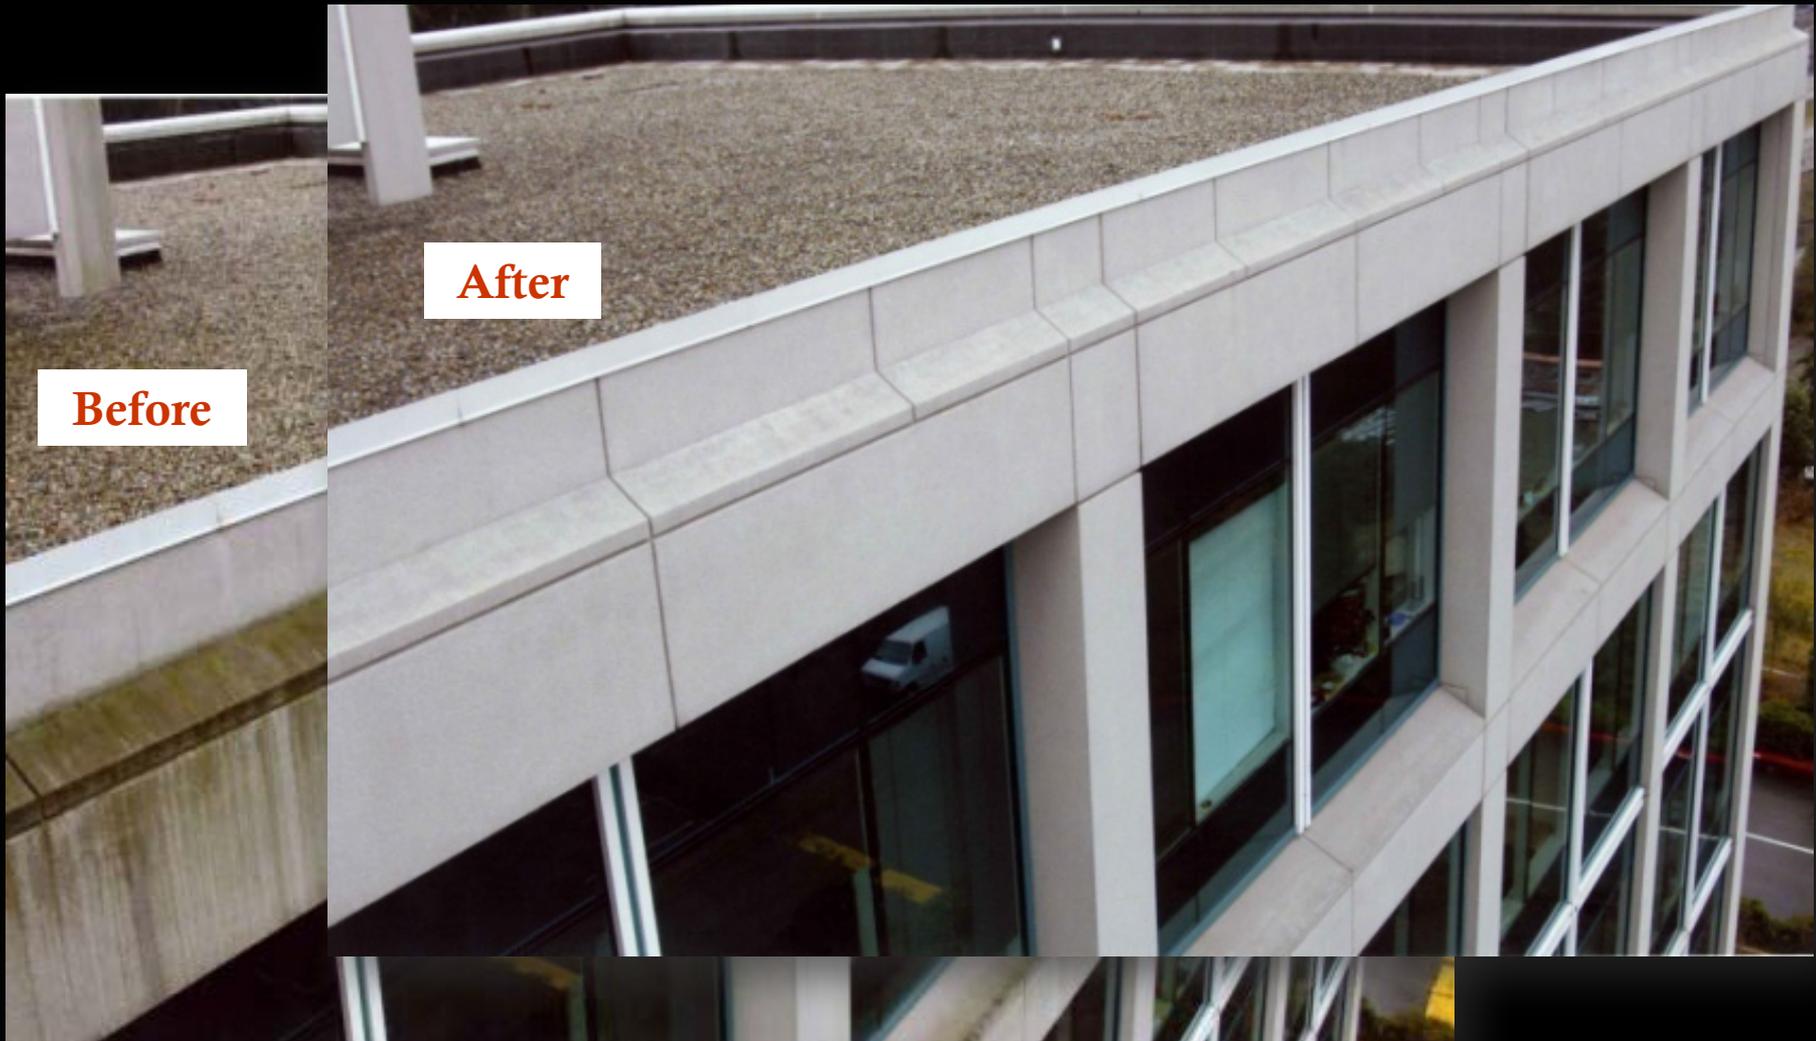
Before and After – Cleaning

Before

After

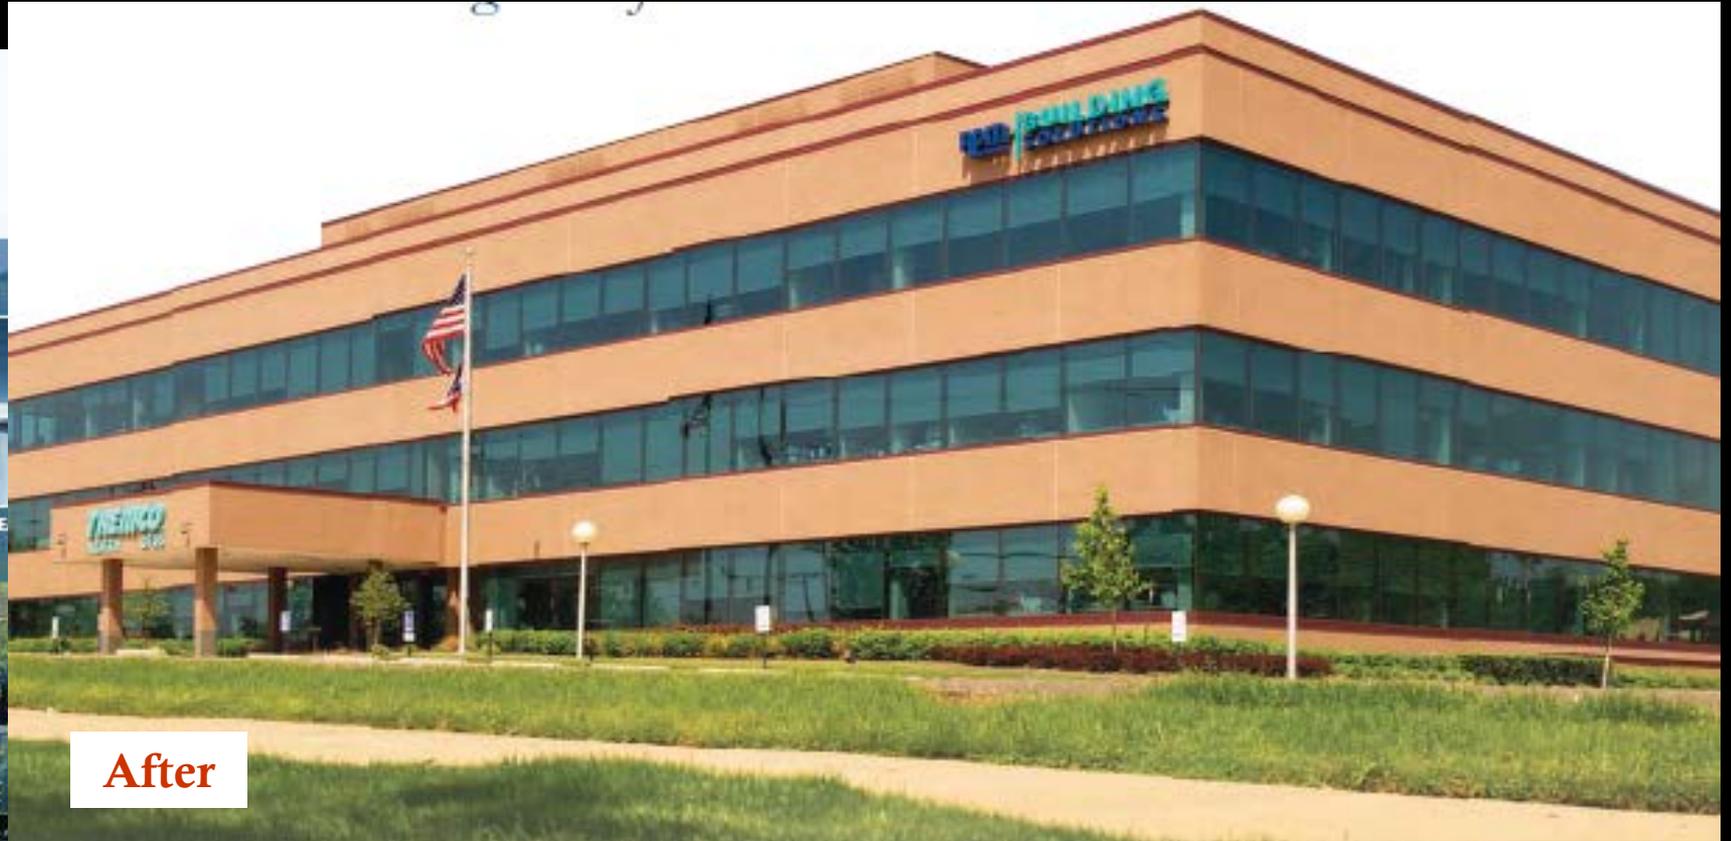
Before and After - Renovation

After
