An Holistic Approach

to ensuring that hospitals function
to maximum efficiency
following severe hurricanes in the Caribbean

Tony Gibbs FREng

Consultant to the Pan American Health Organisation

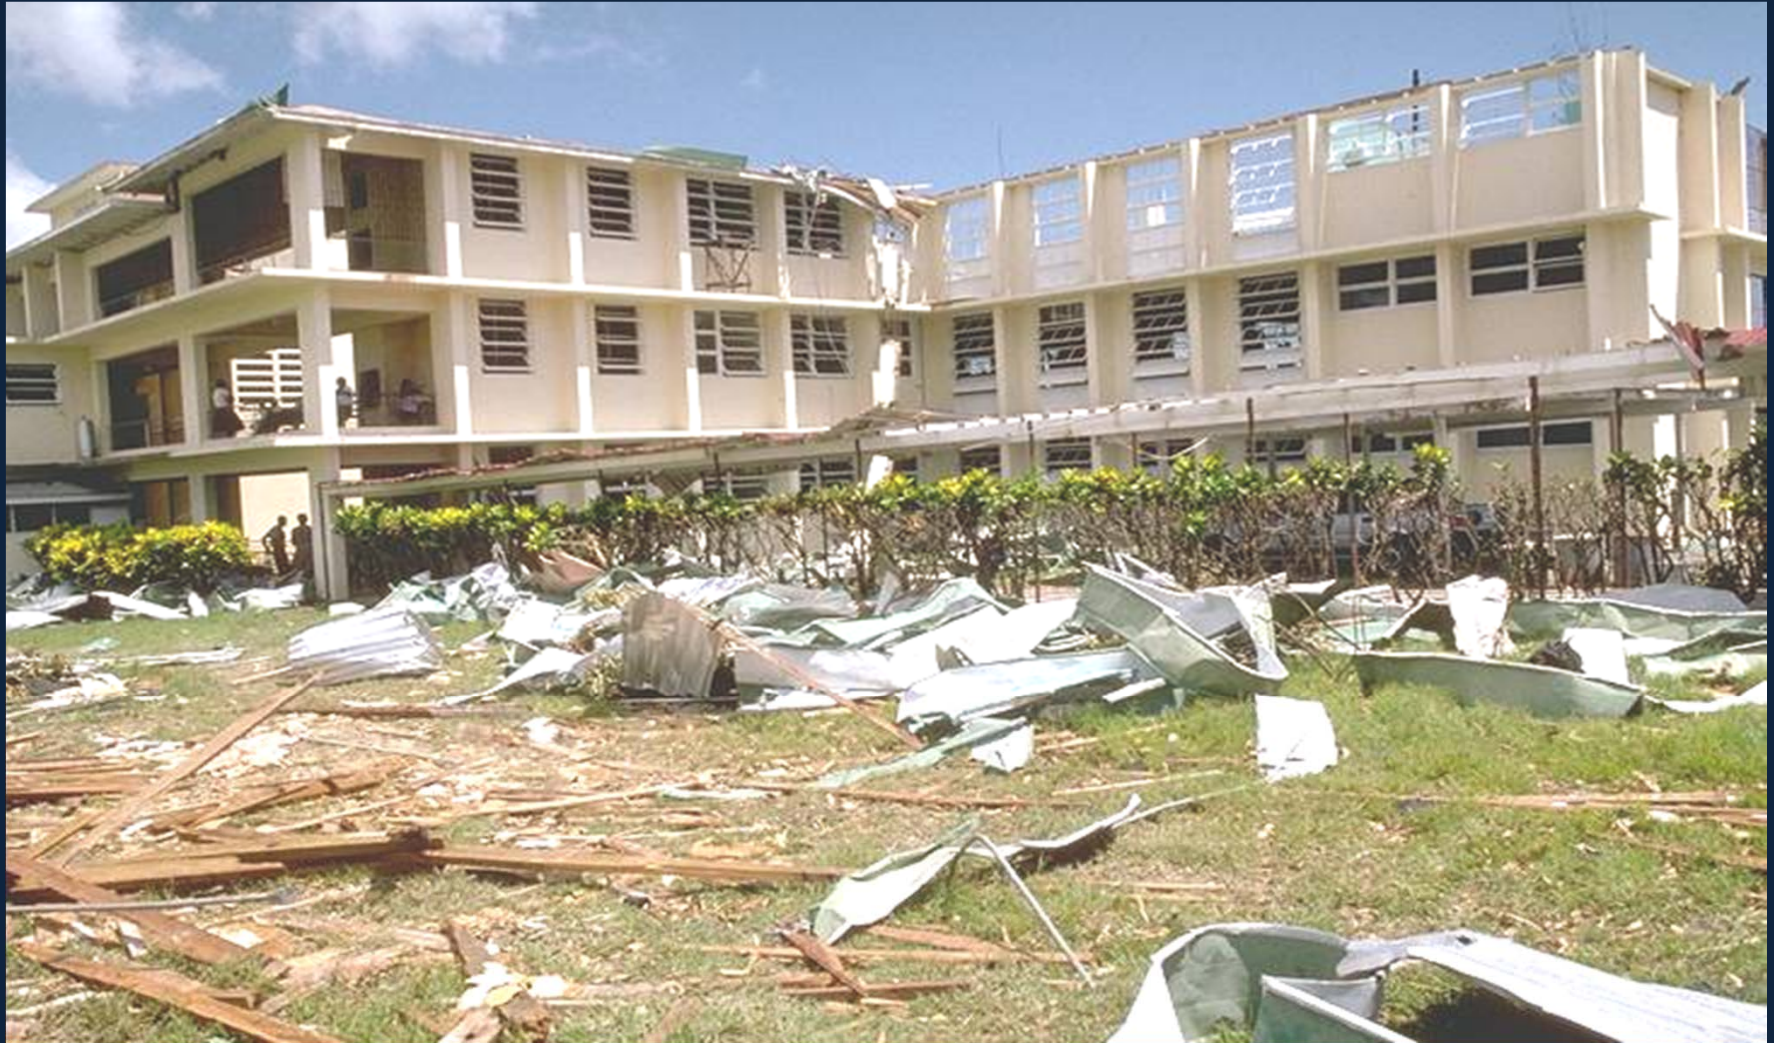
**Princess Margaret Hospital, Jamaica
Hurricane Gilbert (1988)**

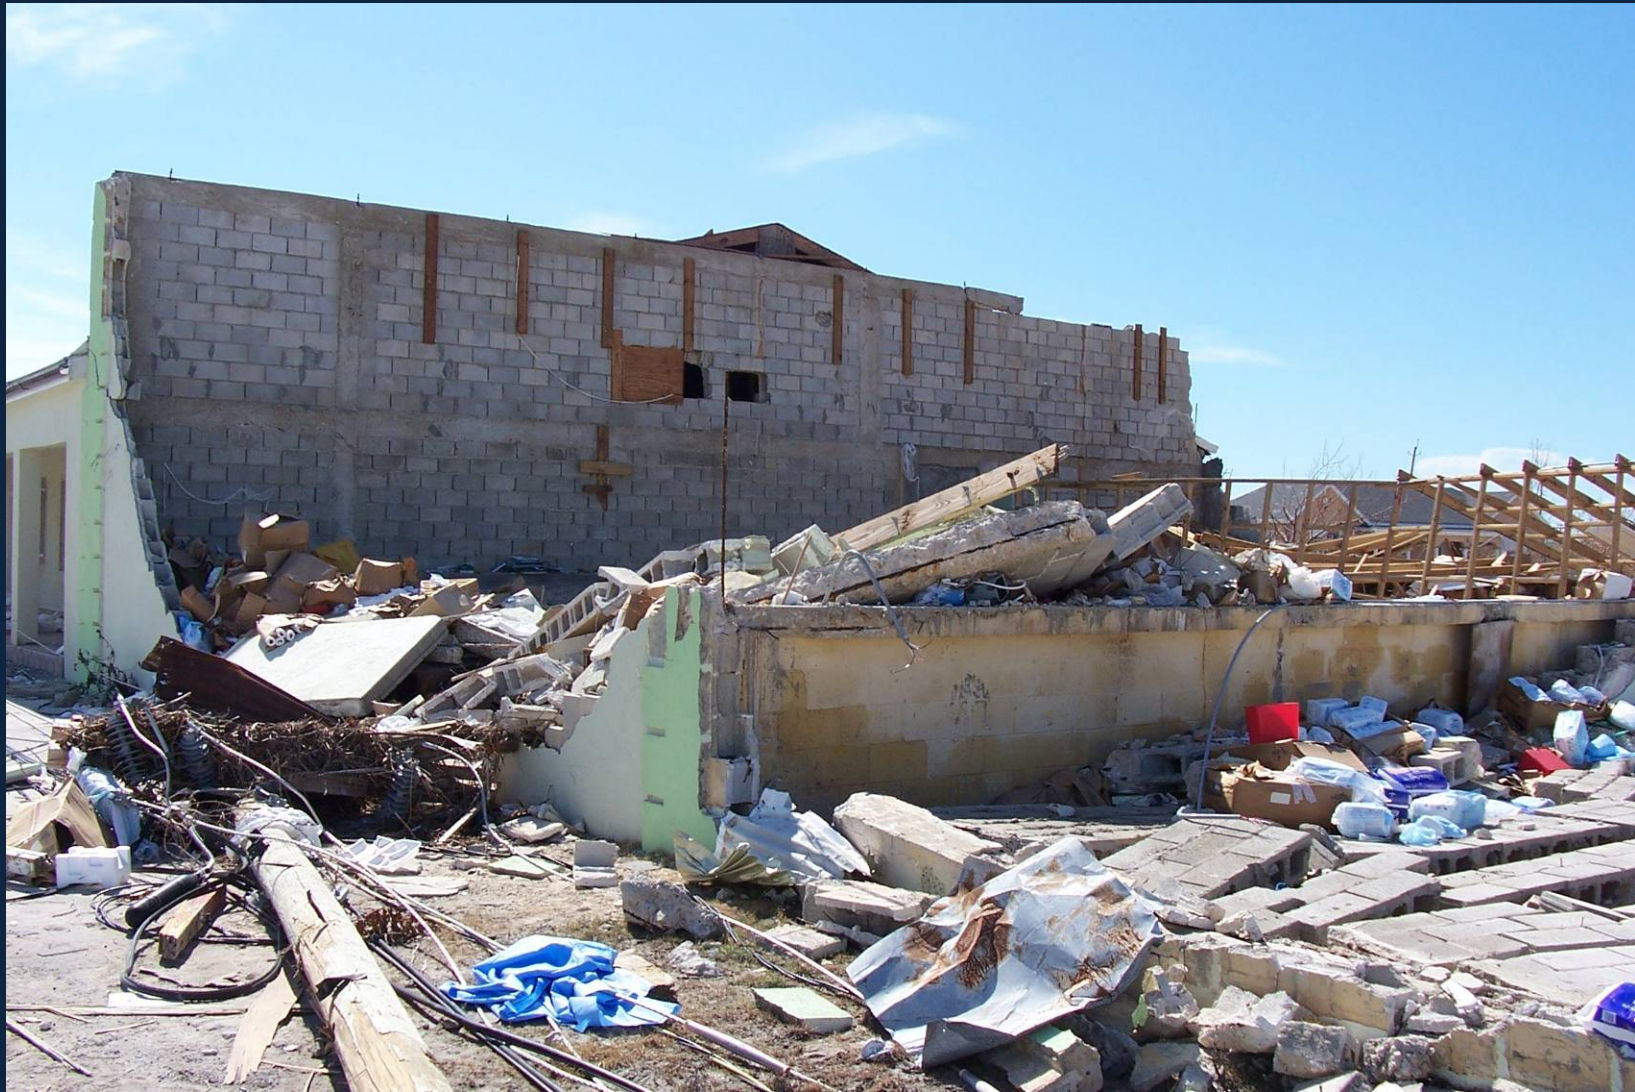
**Central Medical Stores, Grand Turk
(Hurricane Ike, 2008)**

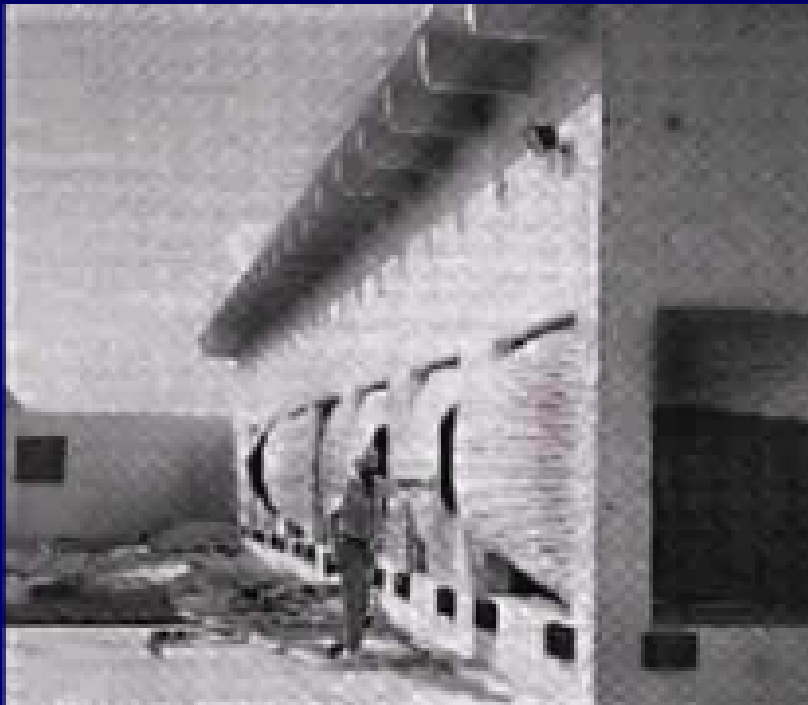
Wind patterns around buildings

Outward pressure on four of the five surfaces
Inward pressure on the windward face only

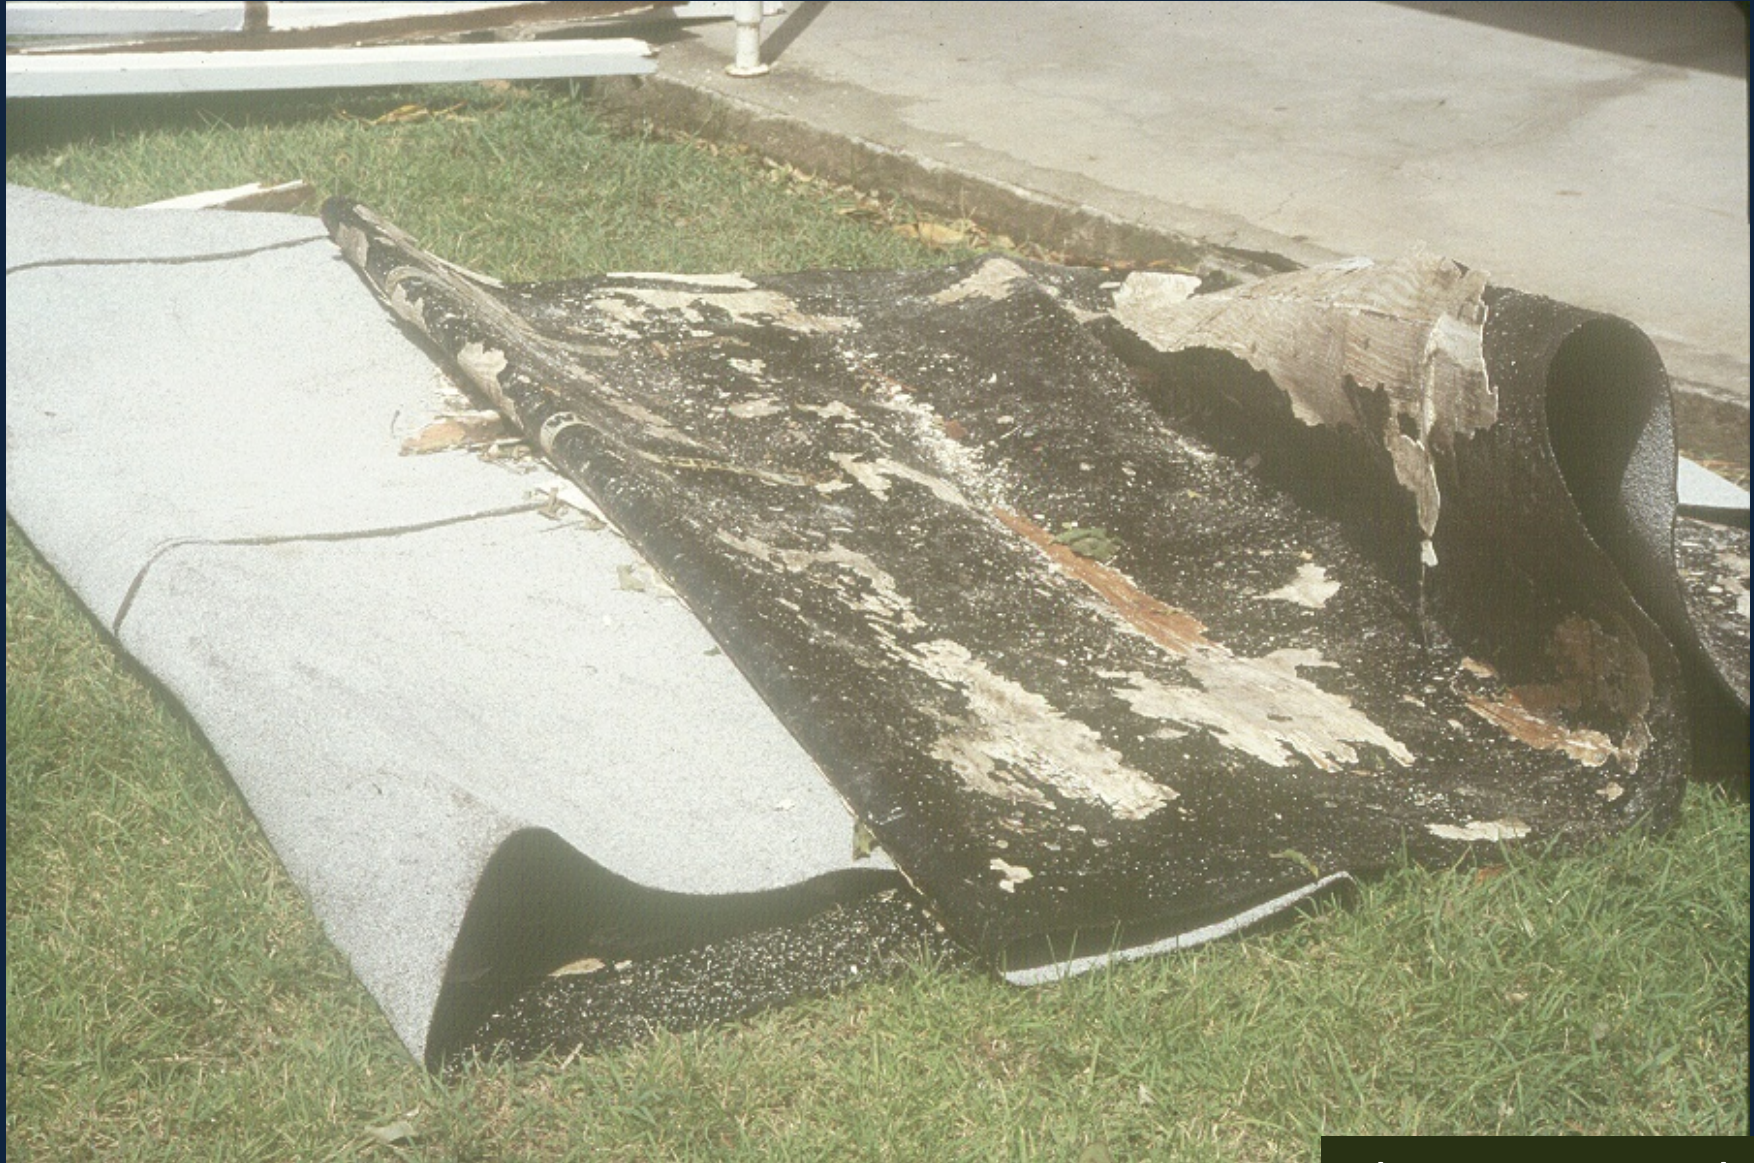
Waterproof membrane removed

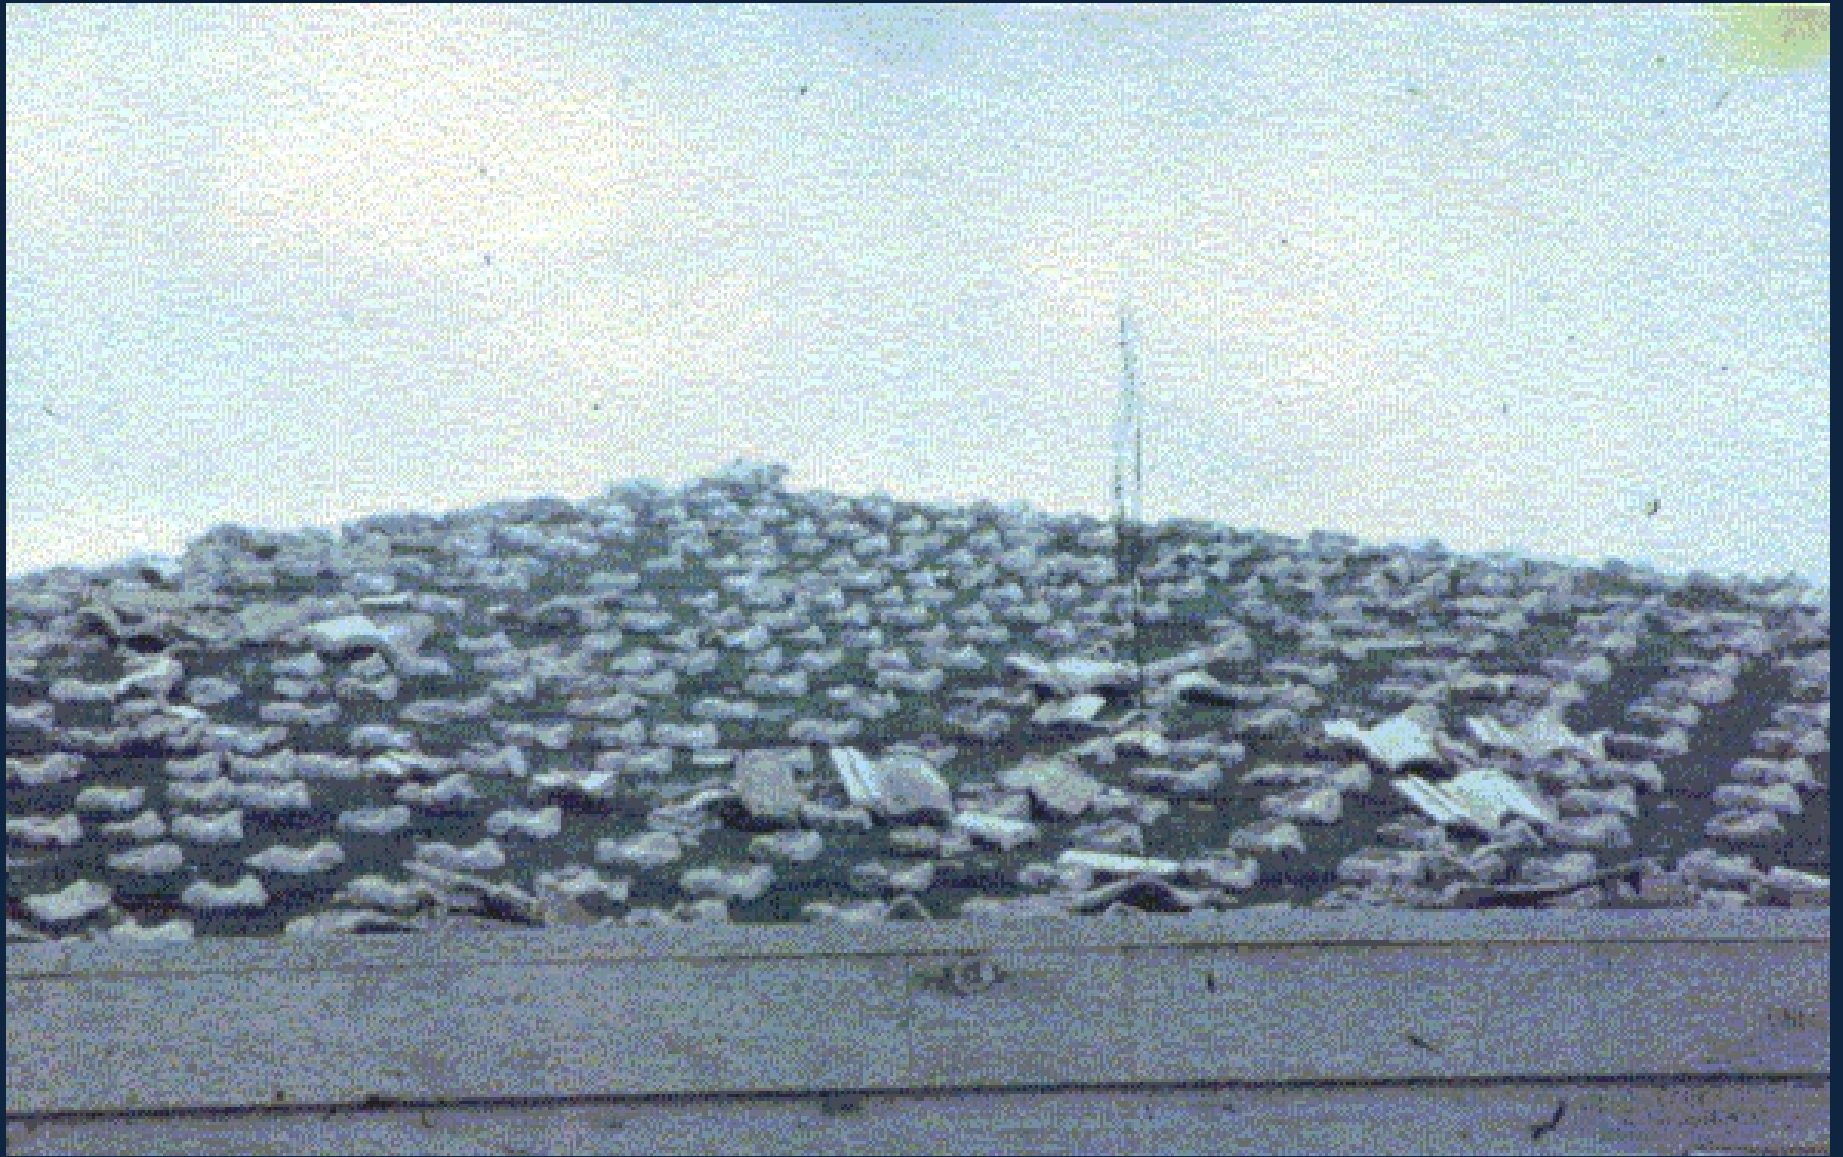
Loss of Spanish tiles – Miami, Hurricane Andrew, 1992

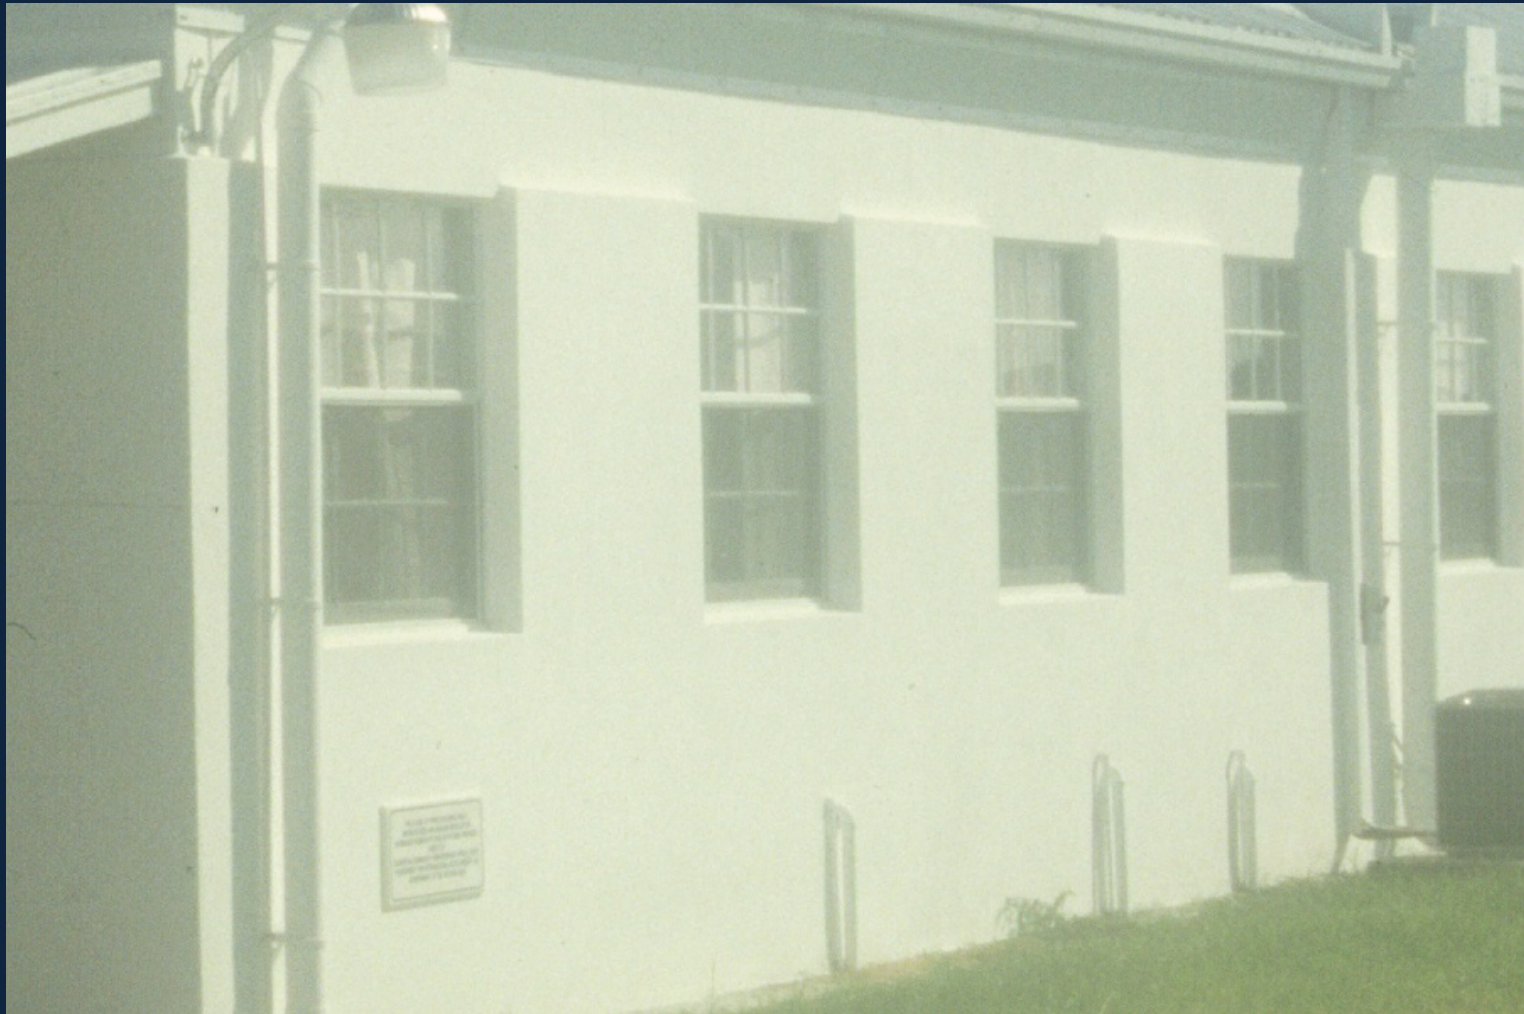
Polycarbonate, impact-resistant windows
